Inspection Report

Property Address:
1212 Whispering Waters Way
Virginia Beach VA 23454

Date: 5/17/2021	Time: 12:00 PM	Report ID: 20210517-Great-Neck
Property: 1212 Whispering Waters Way Virginia Beach VA 23454	Customer: Blue Box Auctions	Real Estate Professional: Alexandrea Perecko RE/MAX Alliance

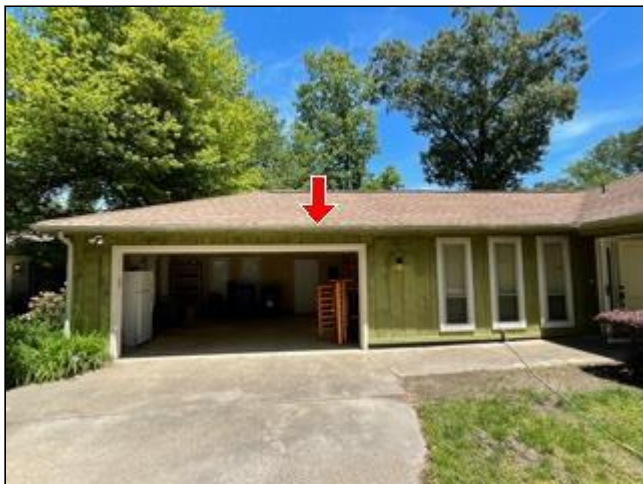
Item 1 - Item 1(Picture)

- 1 Properly secure loose gutters and slope towards downspouts to direct water away from structure.

1.3 Properly secure loose gutters and slope towards downspouts to direct water away from structure.

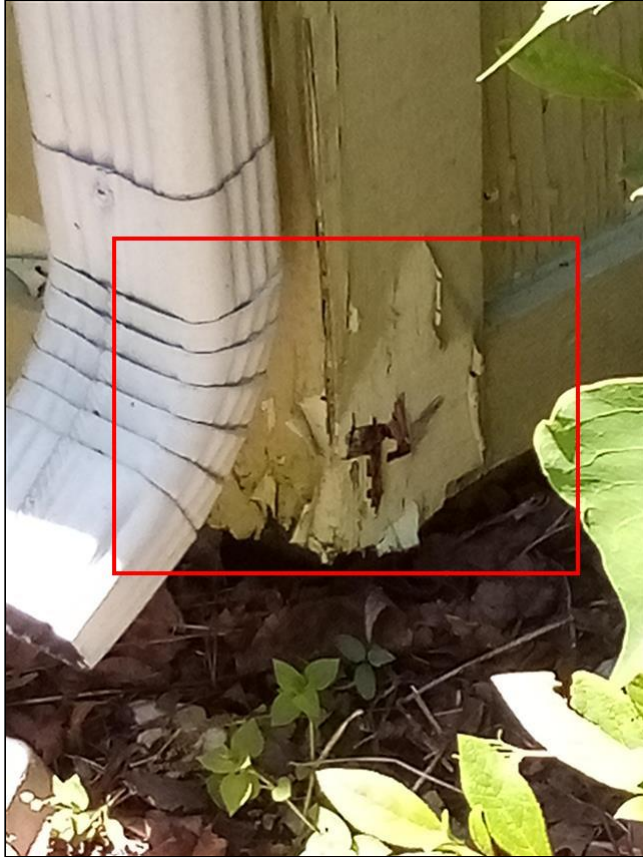
Item 2 - Item 1(Picture) Left rear

- 2 (1) Moisture damage t111 siding - noted, but not limited to left rear exterior. Have a qualified contractor evaluate, correct the source of moisture intrusion, determine the extent of damages beneath finishing materials and properly repair all damage.

- 2.0** (1) Moisture damage t111 siding - noted, but not limited to left rear exterior. Have a qualified contractor evaluate, correct the source of moisture intrusion, determine the extent of damages beneath finishing materials and properly repair all damage.

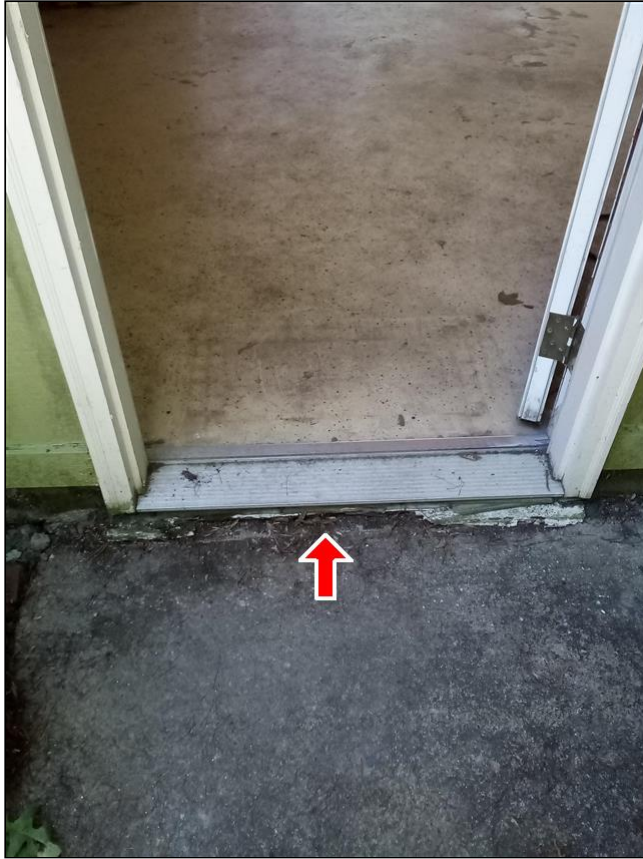
Item 3 - Item 1(Picture) Left front

- 3 Have a qualified contractor replace moisture damaged threshold support at left front exterior door to avoid potential further damage or personal injury.

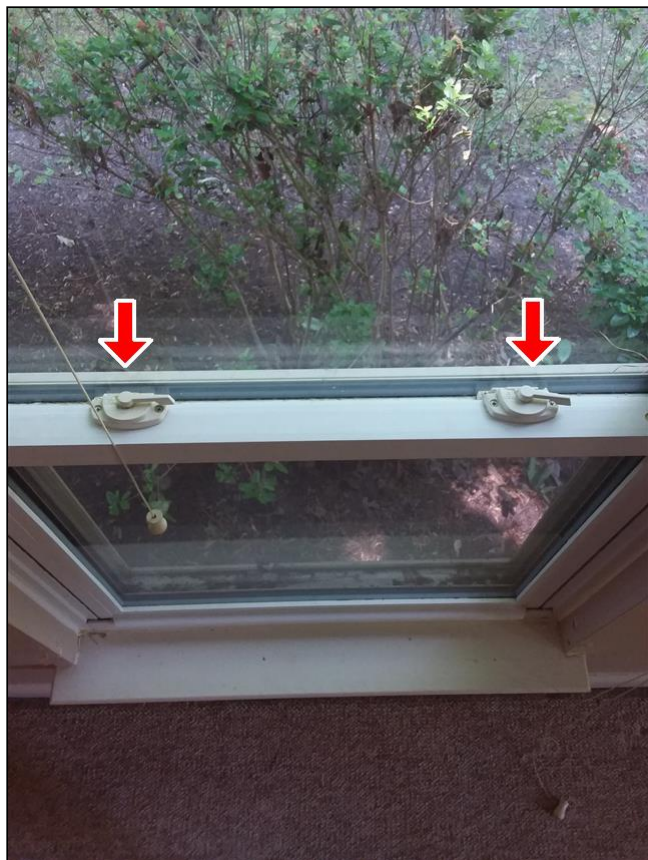
Item 4 - Item 1(Picture) master bedroom

- 4 (1) Master bedroom window will not properly secure. Have a qualified contractor evaluate and repair/ replace as needed.

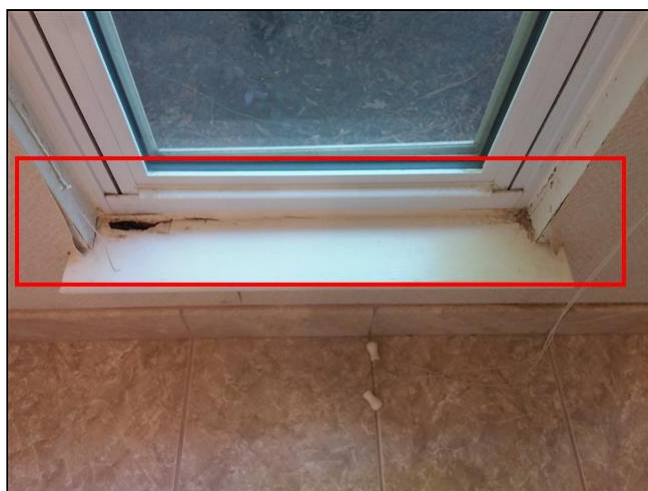
Item 5 - Item 1(Picture)

- 5 (2) Moisture damage in the window sill/ trim noted, but not limited to master bath. Have a qualified contractor evaluate, correct the source of moisture intrusion, determine the extent of damage beneath finishing materials and properly repair/ replace all damaged materials.

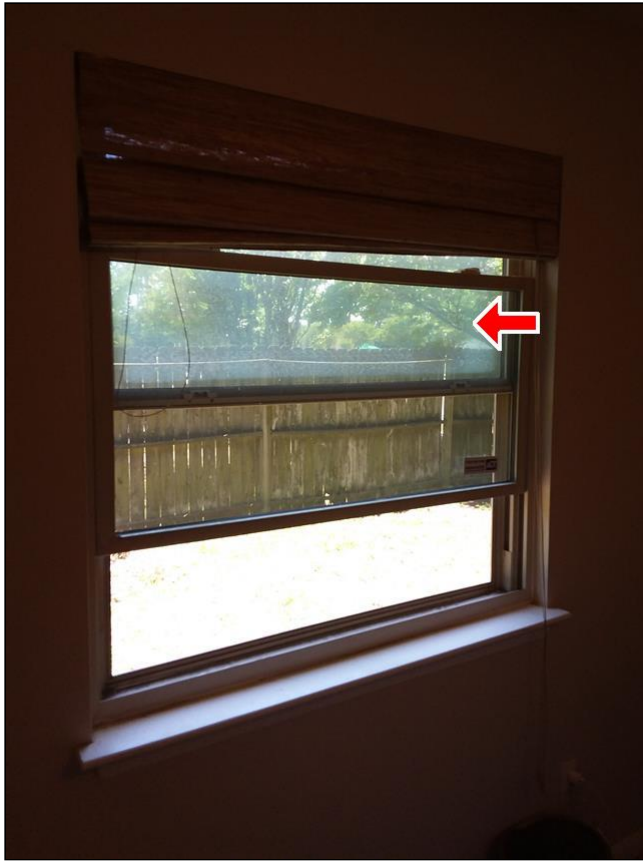
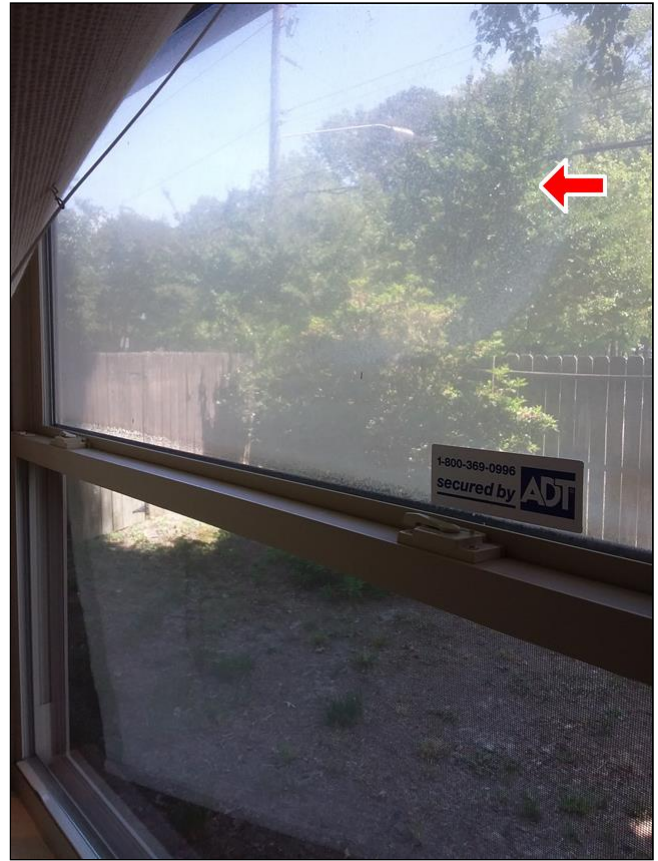
- 6 (3) Failed seal between double panes of glass noted, but not limited to rear right bedroom and common room at rear. Windows have fogged. Have a qualified window contractor properly repair/ replace all damaged windows.

Item 6 - Item 1(Picture) Rear right bedroom

Item 6 - Item 2(Picture) Common room rear wall

- 2.2** (3) Failed seal between double panes of glass noted, but not limited to rear right bedroom and common room at rear. Windows have fogged. Have a qualified window contractor properly repair/ replace all damaged windows.

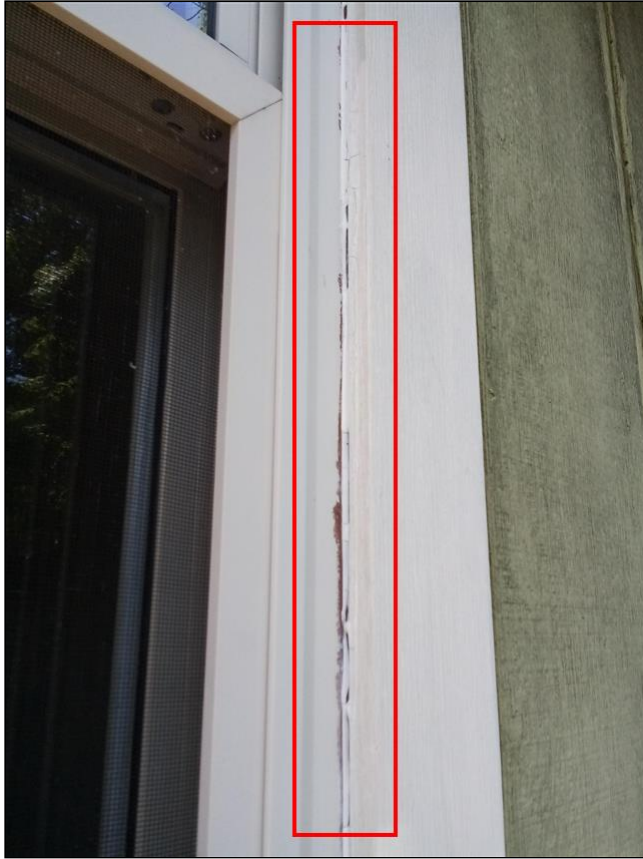
Item 7 - Item 1(Picture) rear

- 7 (4) Recommend sealing any cracks and gaps around all windows and doors to avoid issues related to moisture/ air penetration.

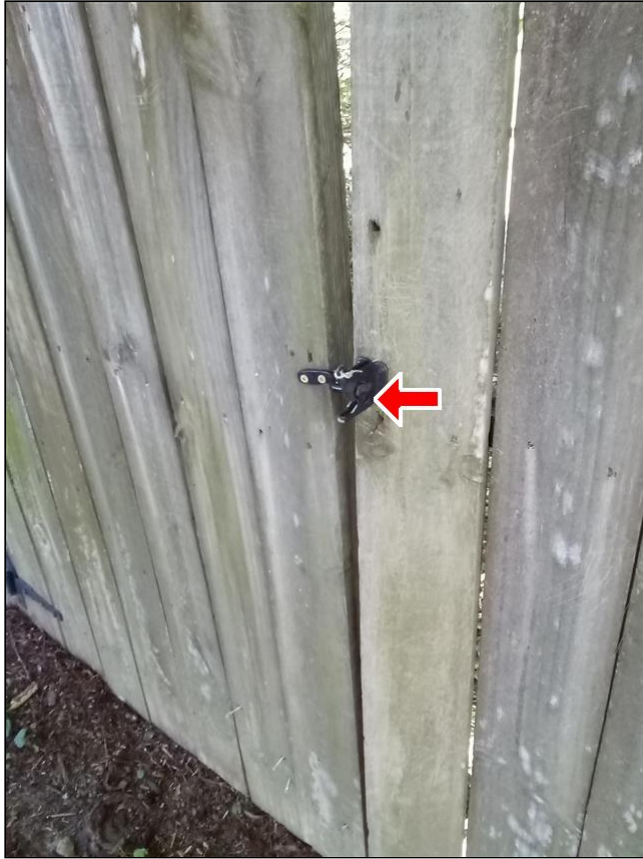
Item 8 - Item 1(Picture)

- 8 Security gate hardware at left exterior binds/ will not easily open or close. Have a qualified contractor evaluate and repair as needed to achieve normal, safe function.

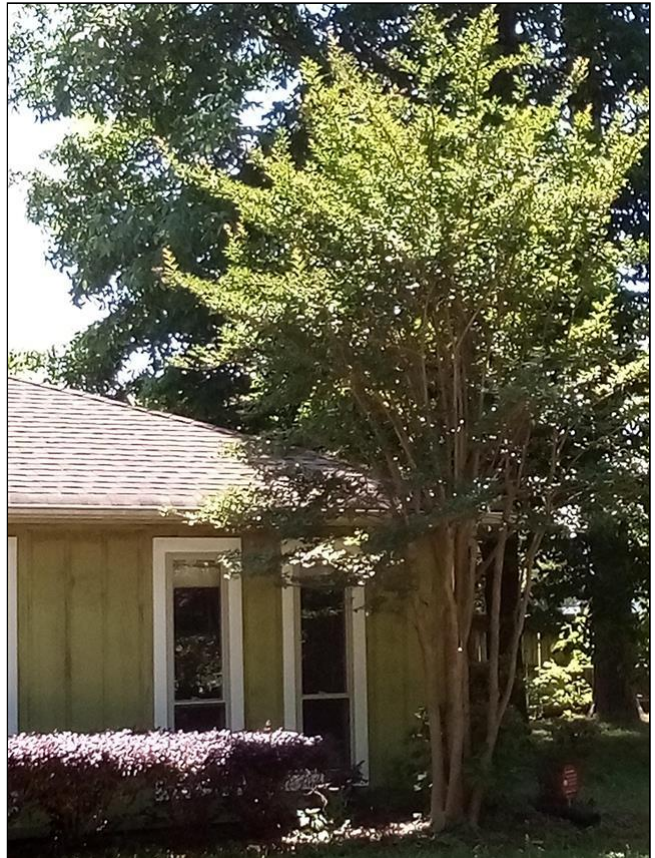
- 9 (1) Monitor trees in close proximity to structure as they may cause damage due to branch and root movement.

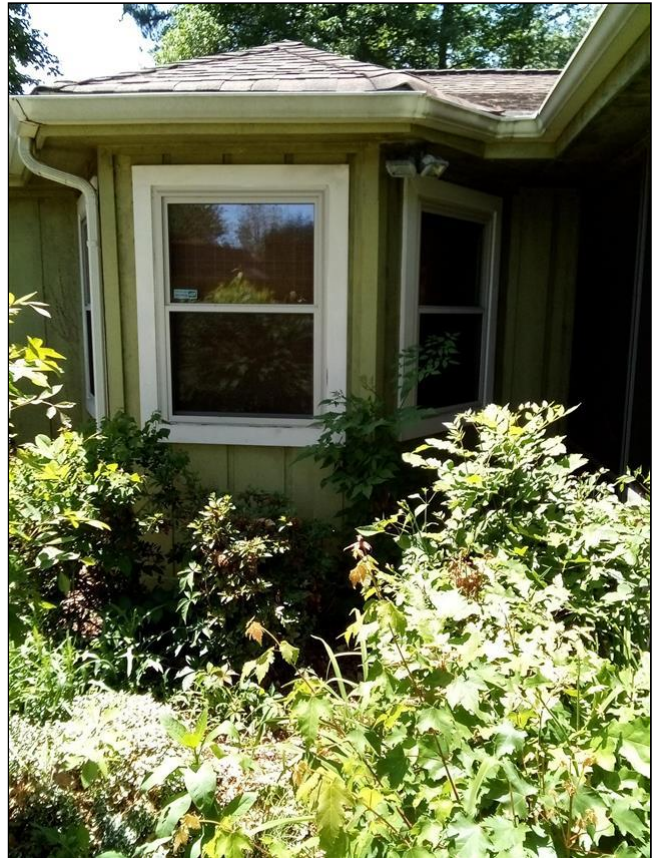
10 (2) Trim and maintain vegetation away from structure

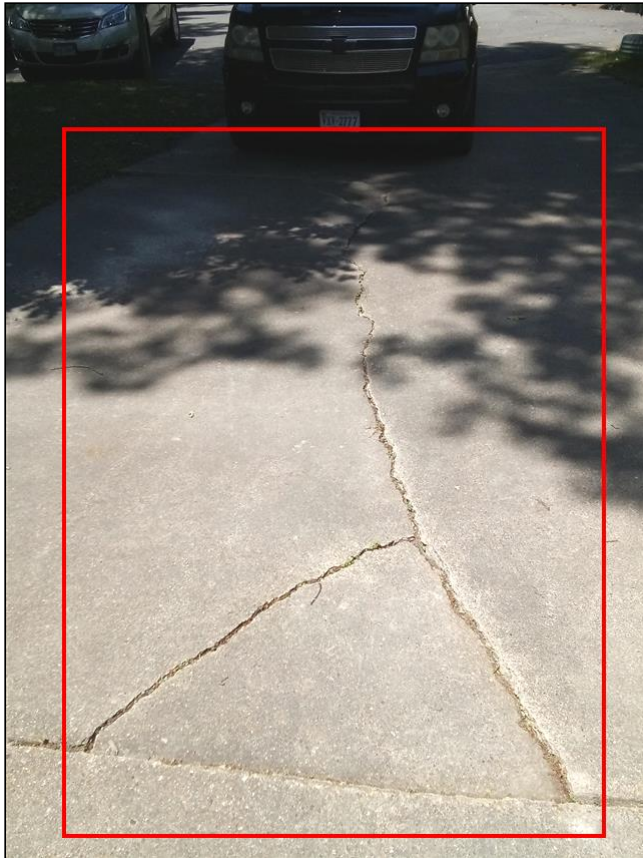
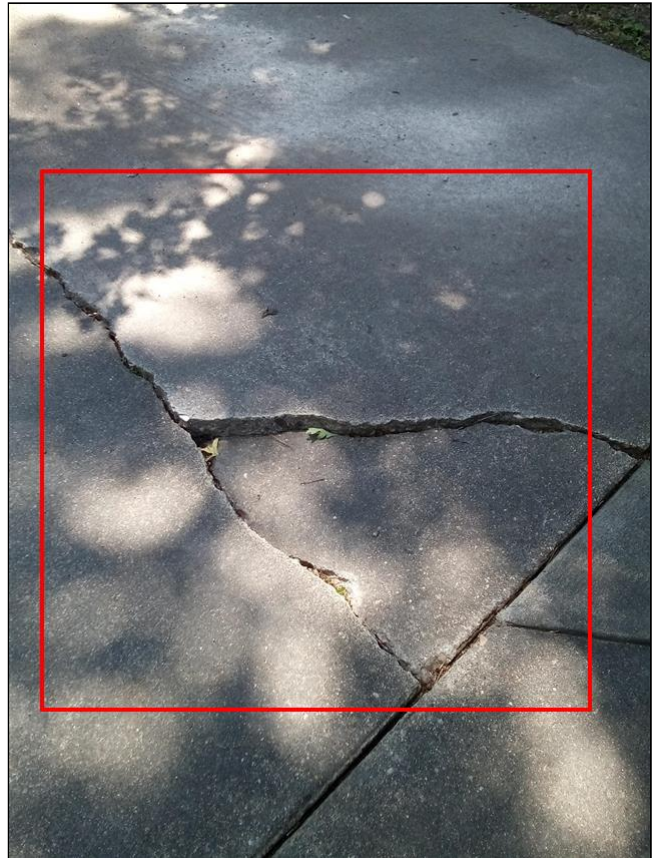
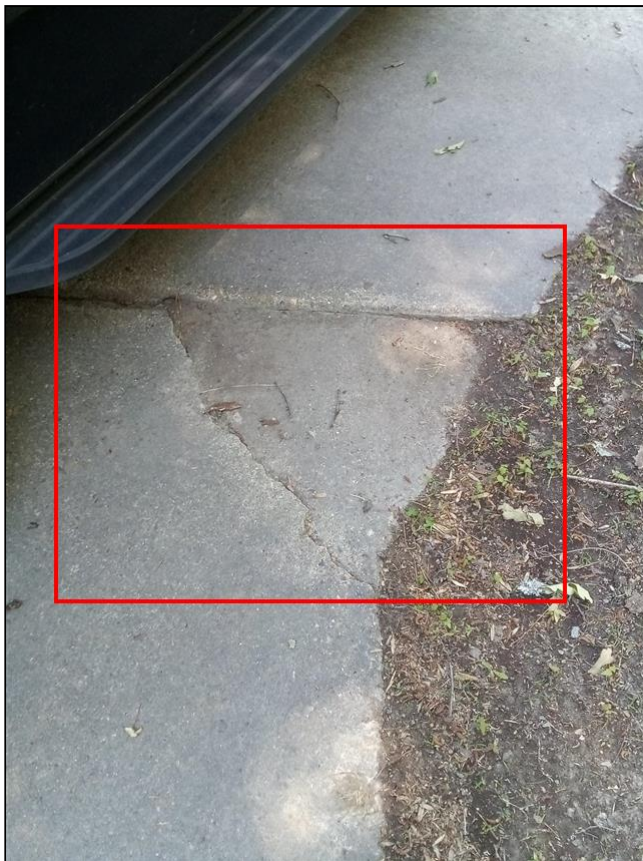
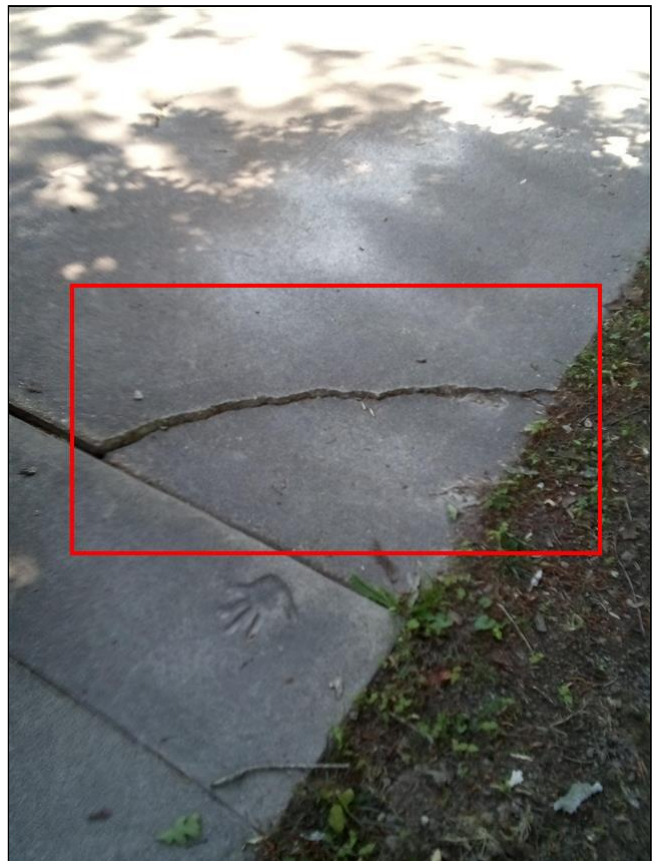
- 11 (3) Driveway surface is cracking/ heaving in areas - likely due to tree root movement - and presents a potential trip hazard in its present condition. Suggest evaluation and repair (ease transitions) or replacement by a qualified professional.

- 2.4** (3) Driveway surface is cracking/ heaving in areas - likely due to tree root movement - and presents a potential trip hazard in its present condition. Suggest evaluation and repair (ease transitions) or replacement by a qualified professional.

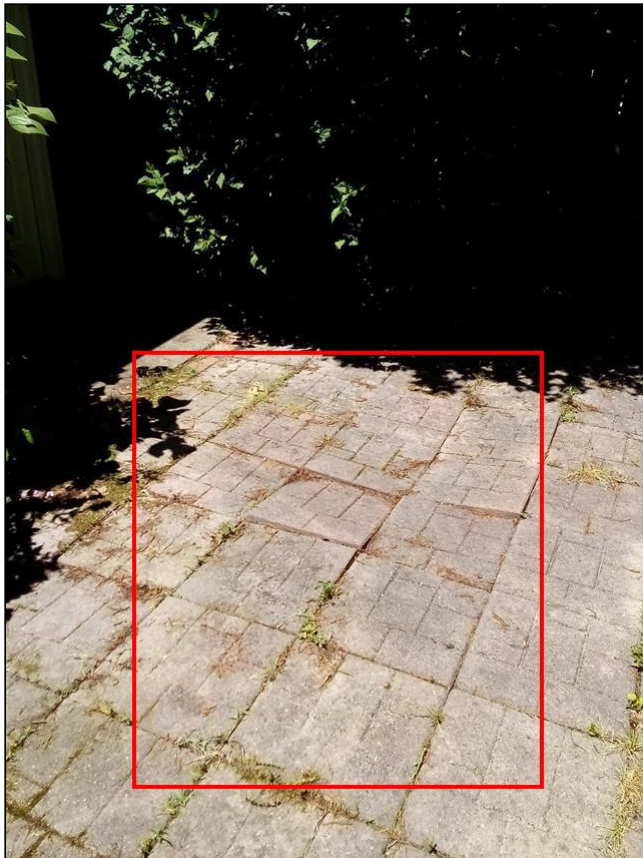
Item 12 - Item 1(Picture)

- 12 (4) Apparent backfill settlement at left exterior patio has created an unlevel surface and a potential trip hazard. Recommend evaluation and repair as needed by a qualified contractor.

- 2.4** (4) Apparent backfill settlement at left exterior patio has created an unlevel surface and a potential trip hazard. Recommend evaluation and repair as needed by a qualified contractor.

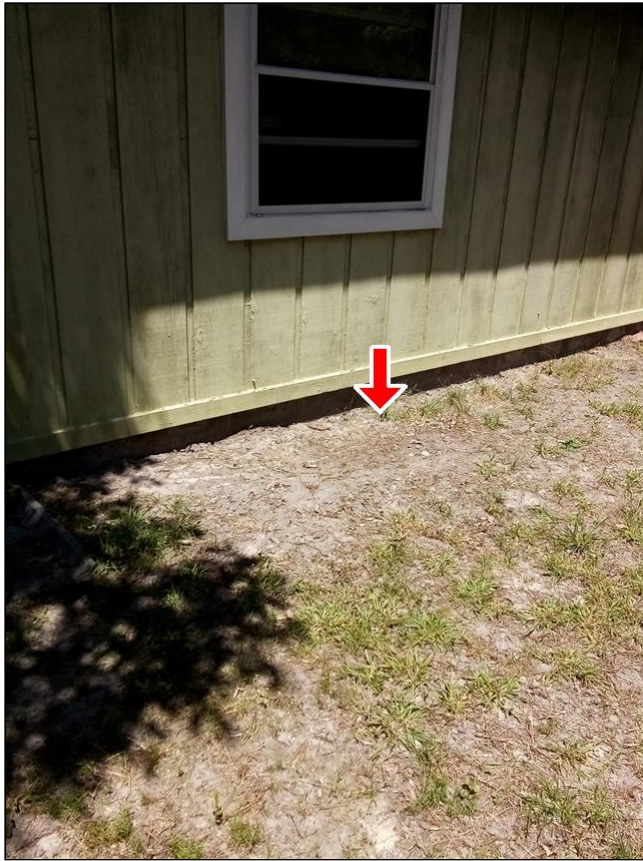
Item 13 - Item 1(Picture)

- 13 (5) There is a negative slope at the rear right of home that can cause or contribute to water intrusion or deterioration. I recommend correcting landscape to drain water away from home.

- 2.4** (5) There is a negative slope at the rear right of home that can cause or contribute to water intrusion or deterioration. I recommend correcting landscape to drain water away from home.

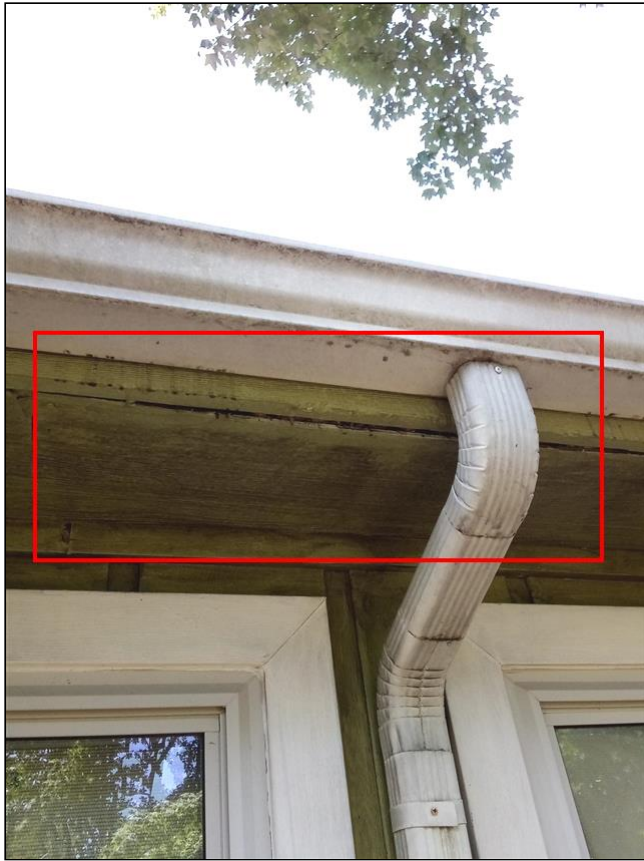
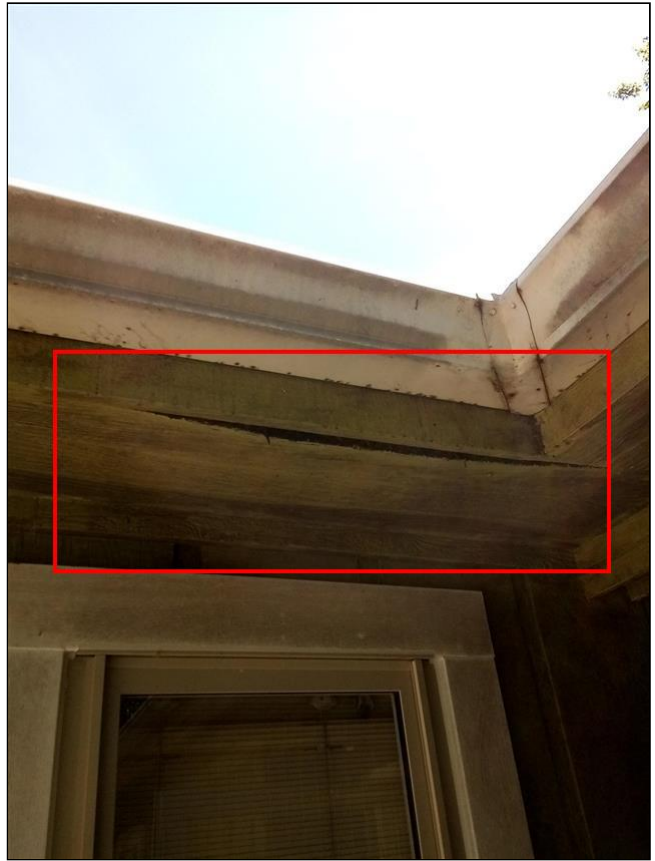
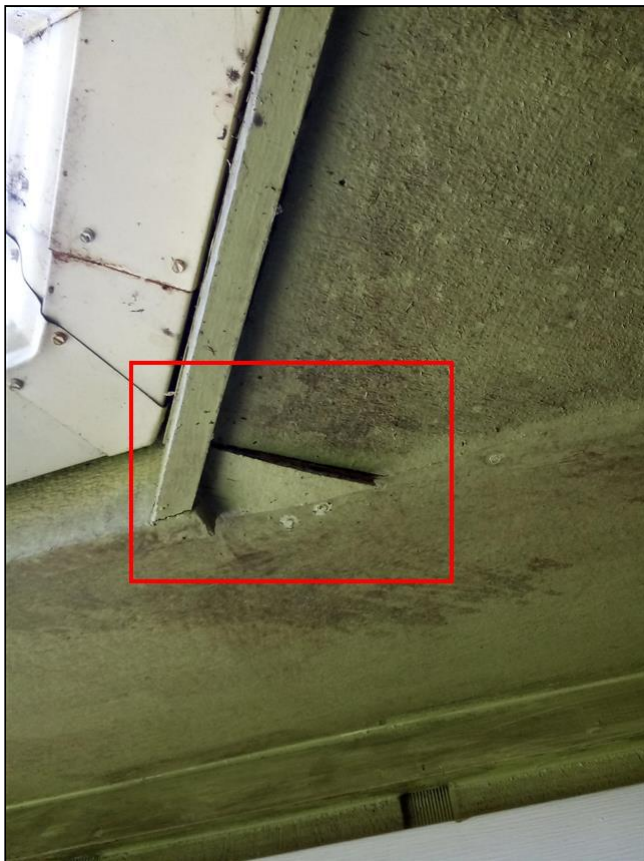
- 14** (1) Secure loose soffits as needed to avoid moisture, insect or rodent intrusion and subsequent damages.

Item 14 - Item 1(Picture) rear

Item 14 - Item 2(Picture) front

Item 14 - Item 3(Picture) left rear

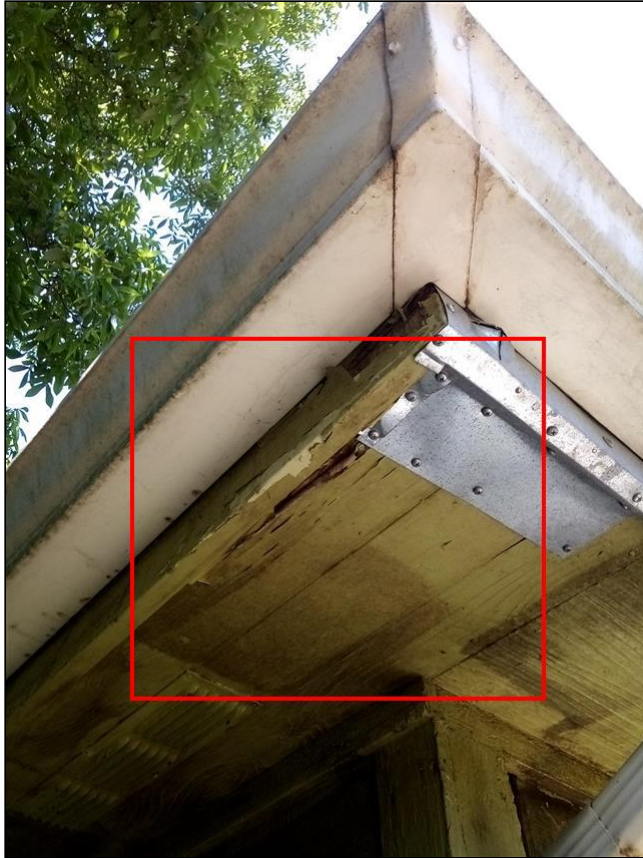
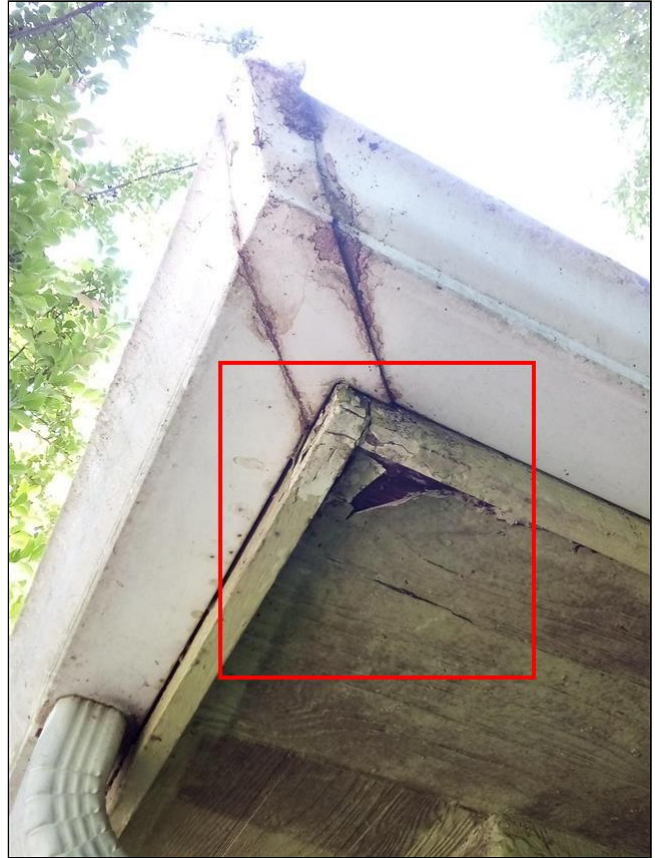
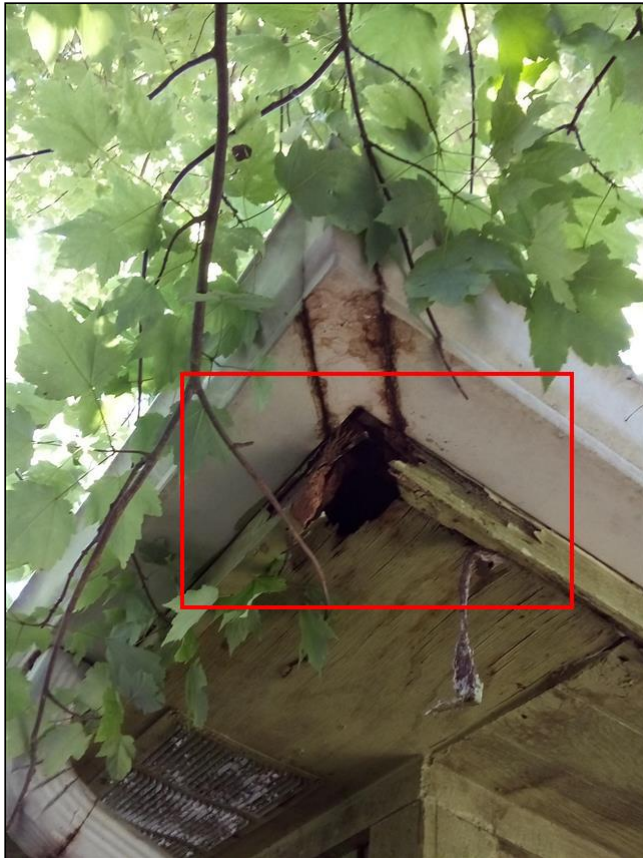
- 15 (2) Moisture damaged soffit/ fascia noted, but not limited to front right corner, rear right corner, front left corner and rear left corner of subject home. Have a qualified professional properly repair all damage.

Item 15 - Item 1(Picture) rear right

Item 15 - Item 2(Picture) front right

Item 15 - Item 3(Picture) front left

Item 15 - Item 4(Picture) rear left

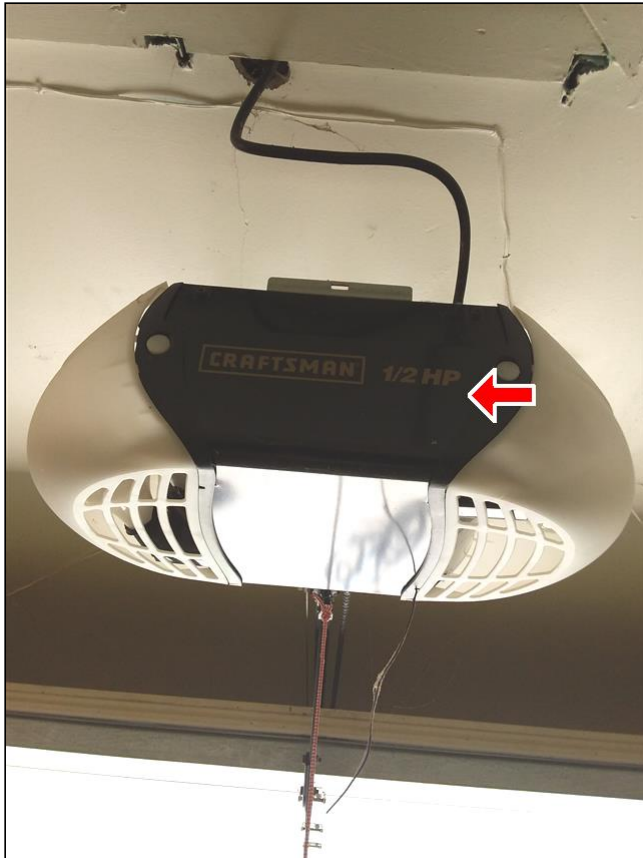
Item 16 - Item 1(Picture)

- 16 (1) Adjust closing force on the automatic door opener to avoid potential personal injury (this is not the eye sensors).

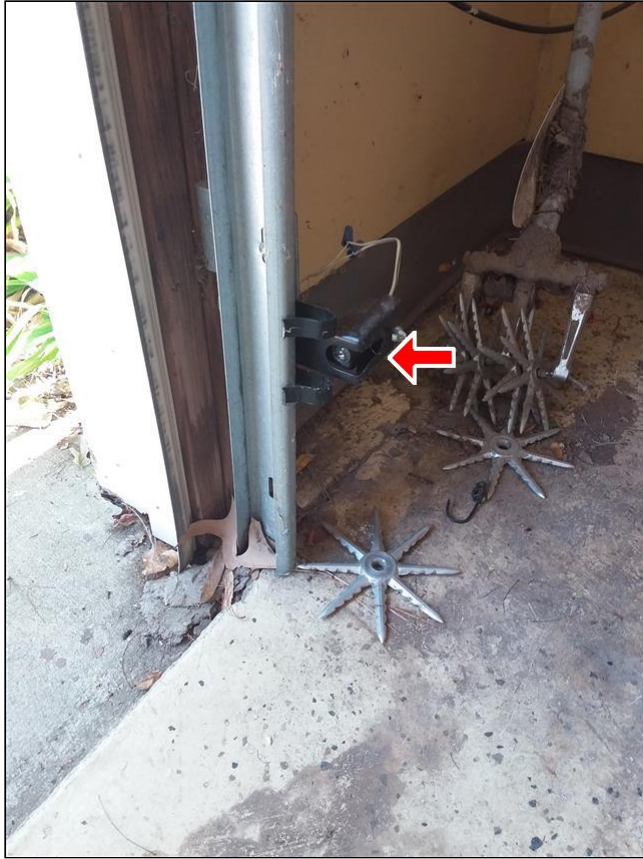
Item 17 - Item 1(Picture)

- 17 (2) Eye sensors are improperly installed. they should be installed per manufacturer specifications with the top of the sensors no higher than 4 to 6 inches off of the ground (currently approx 9"). I recommend having a qualified professional correct to safe function.

3.5 (2) Eye sensors are improperly installed. they should be installed per manufacturer specifications with the top of the sensors no higher than 4 to 6 inches off of the ground (currently approx 9"). I recommend having a qualified professional correct to safe function.

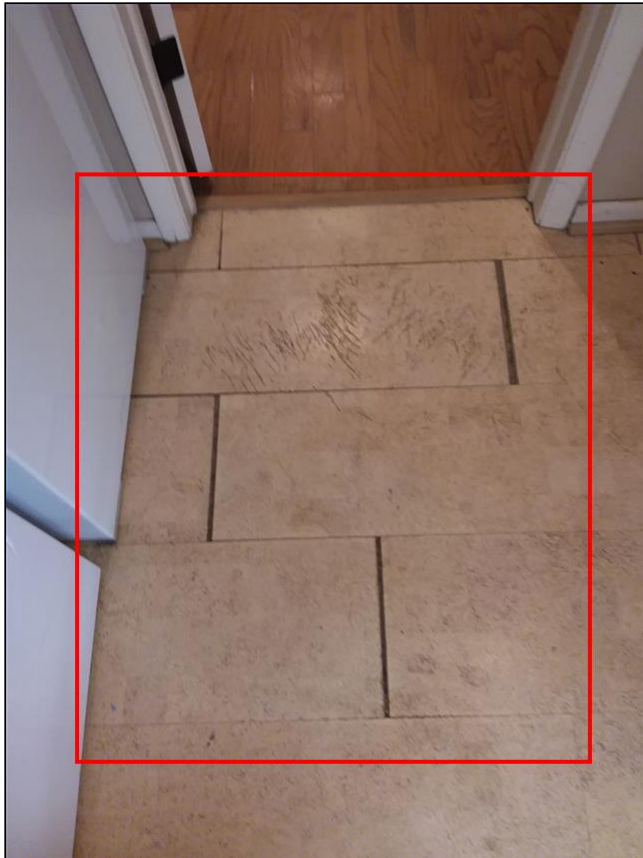
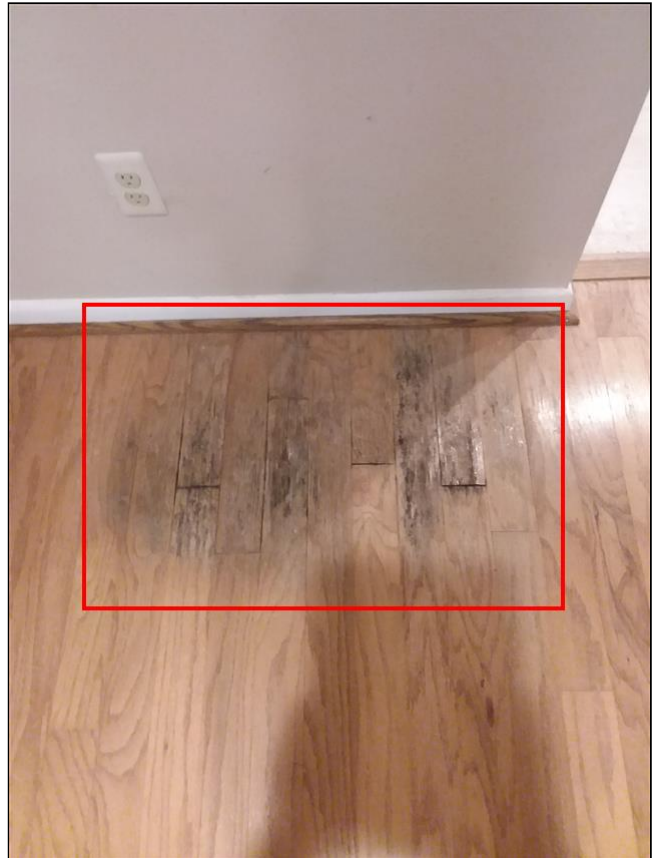
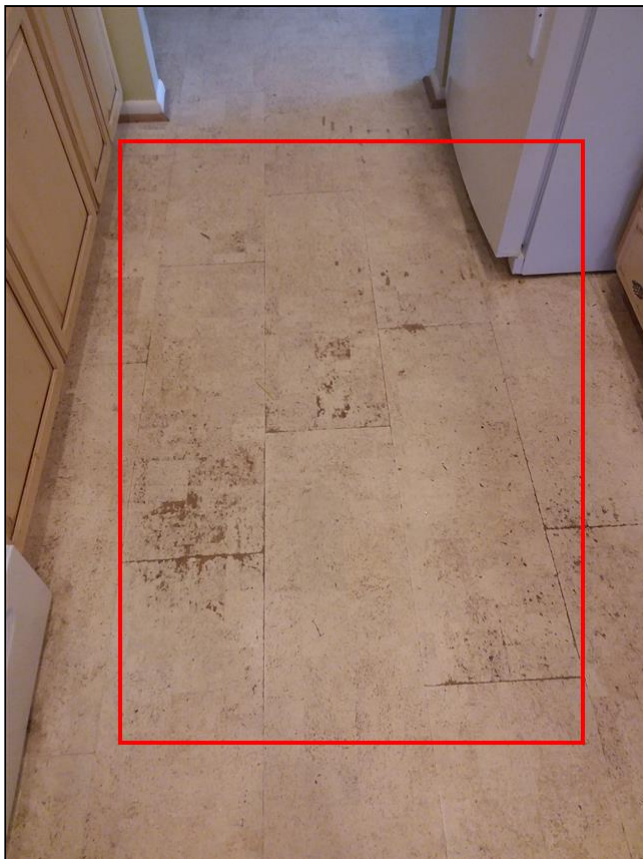
- 18 (1) Damaged, worn, loose flooring noted, but not limited to: see pictures. Have a qualified contractor evaluate and repair / replace as needed.

Item 18 - Item 1(Picture) Washer Dryer Room

Item 18 - Item 2(Picture) Living room - measured dry

Item 18 - Item 3(Picture) Kitchen

4.2 (1) Damaged, worn, loose flooring noted, but not limited to: see pictures. Have a qualified contractor evaluate and repair / replace as needed.

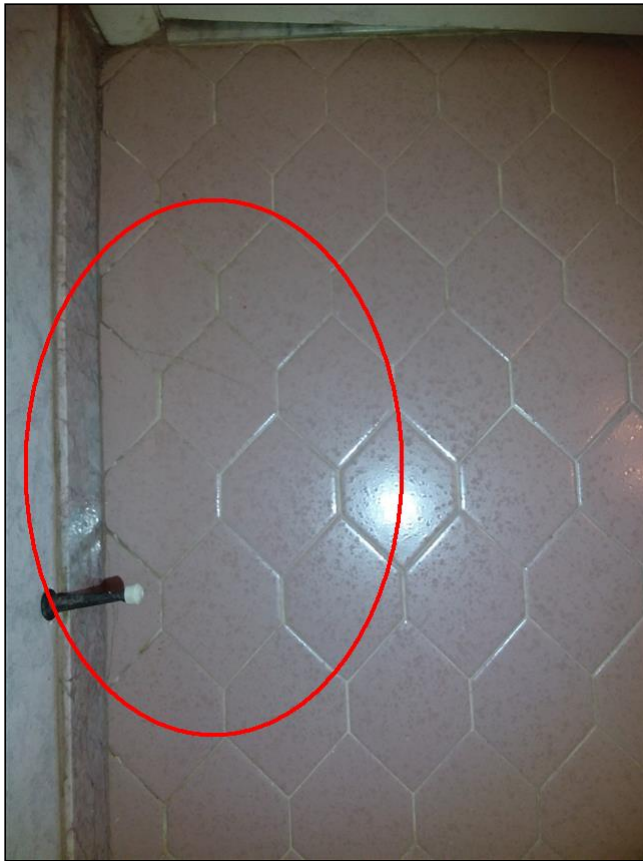
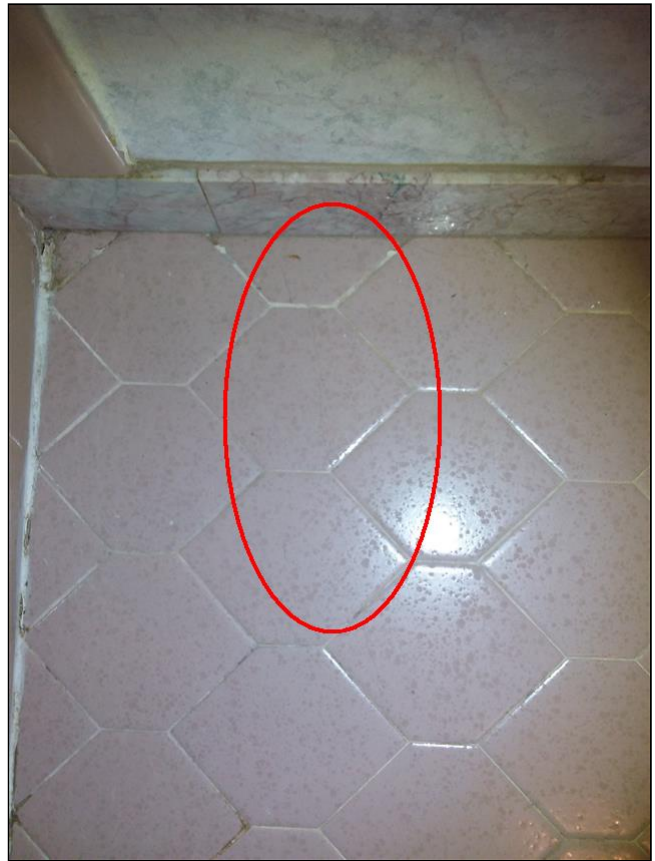
- 19 (2) Cracked floor tile/ deteriorated grout noted, but not limited to: see pictures. Have a qualified contractor evaluate and repair as required.

Item 19 - Item 1(Picture) Hall bath

Item 19 - Item 2(Picture) Hall bath

4.2 (2) Cracked floor tile/ deteriorated grout noted, but not limited to: see pictures. Have a qualified contractor evaluate and repair as required.

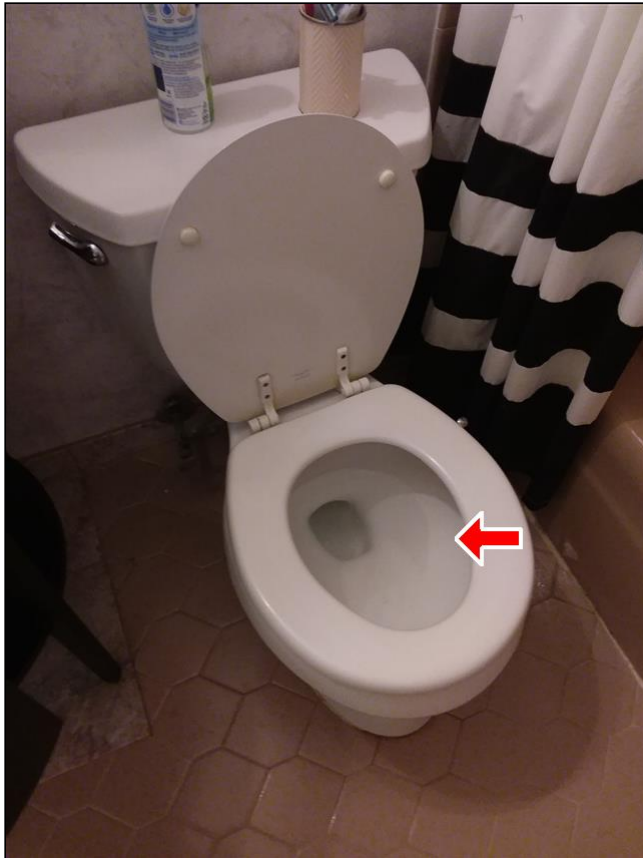
Item 20 - Item 1(Picture)

- 20 Hall bath toilet has a tank to bowl leak, typically a flapper valve adjustment is needed. Have a qualified contractor evaluate and repair as needed.

- 6.0** Hall bath toilet has a tank to bowl leak, typically a flapper valve adjustment is needed. Have a qualified contractor evaluate and repair as needed.

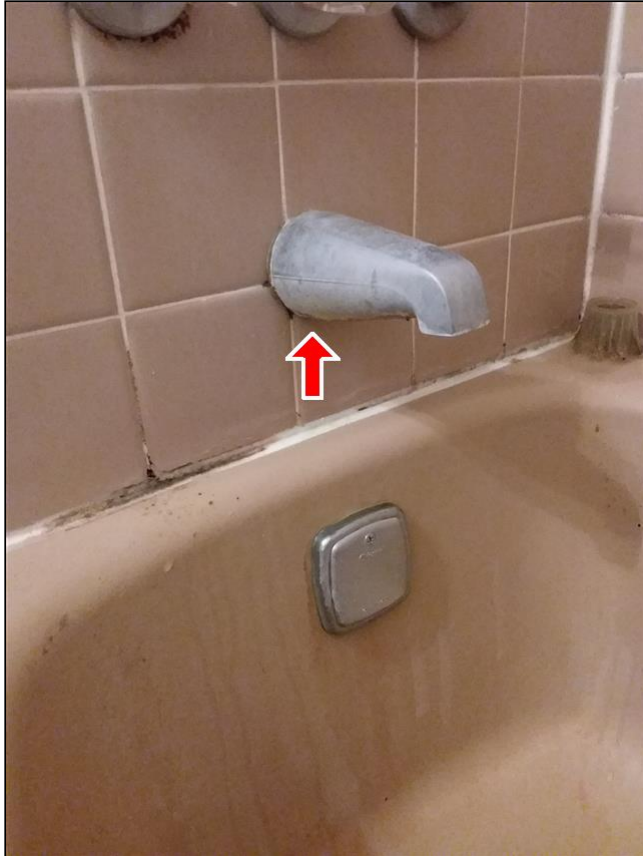
Item 21 - Item 1(Picture)

- 21 (1) Hall bath tub faucet actively leaking at time of inspection. Have a qualified contractor evaluate and repair as needed.

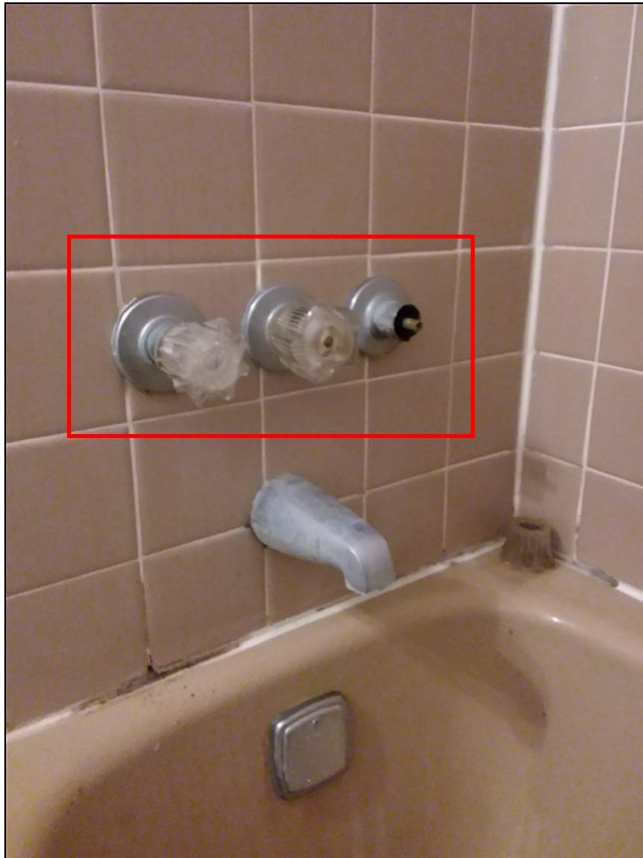
Item 22 - Item 1(Picture)

- 22** (2) Hall bath tub control knobs are damaged and leak when in use. Have a qualified contractor repair/ replace as needed.

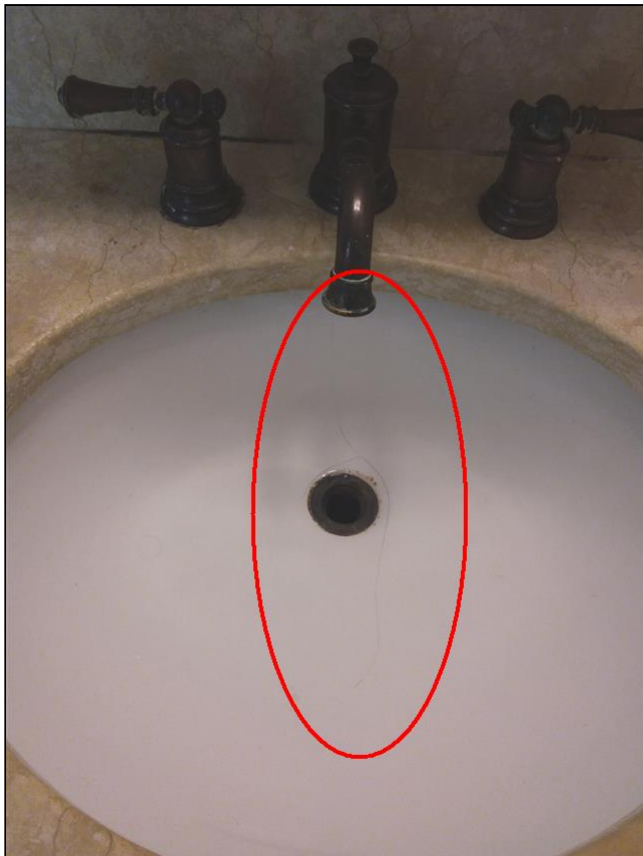
Item 23 - Item 1(Picture)

- 23 (3) Have a qualified contractor repair / replace cracked sink in master bath.

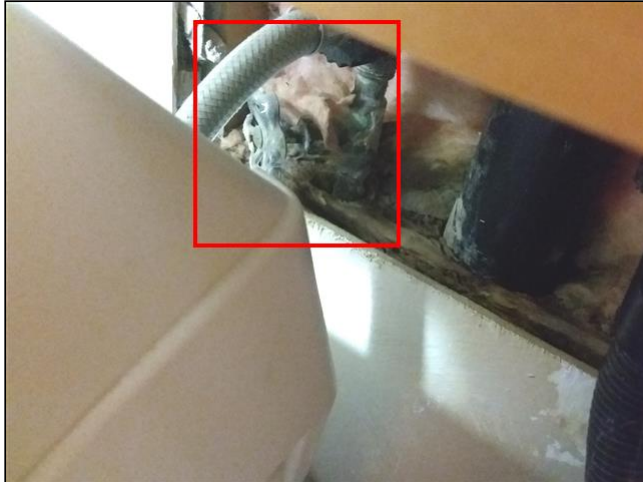
Item 24 - Item 1(Picture)

- 24 (4) Corrosion noted at the washing machine supply line and valve(s). Suggest having a qualified contractor evaluate and repair / replace as needed.

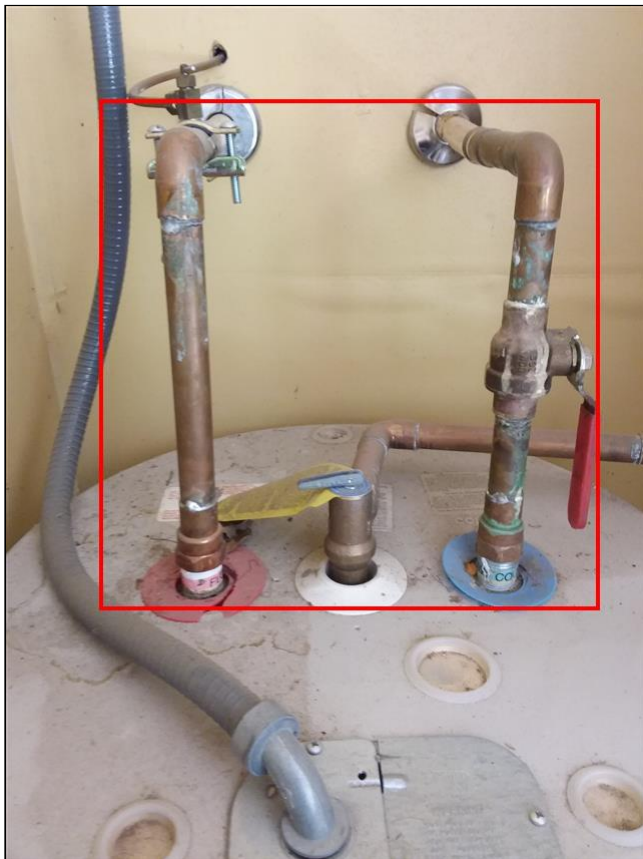
Item 25 - Item 1(Picture)

- 25 Water heater is 15 years old and has exceeded its typical life expectancy of 10-12 years. Corrosion noted at the cold water intake and hot supply lines. Have a qualified plumbing contractor service and evaluate unit for repair vs replacement. Repair/ replace as recommended.

- 6.2** Water heater is 15 years old and has exceeded its typical life expectancy of 10-12 years. Corrosion noted at the cold water intake and hot supply lines. Have a qualified plumbing contractor service and evaluate unit for repair vs replacement. Repair/ replace as recommended.

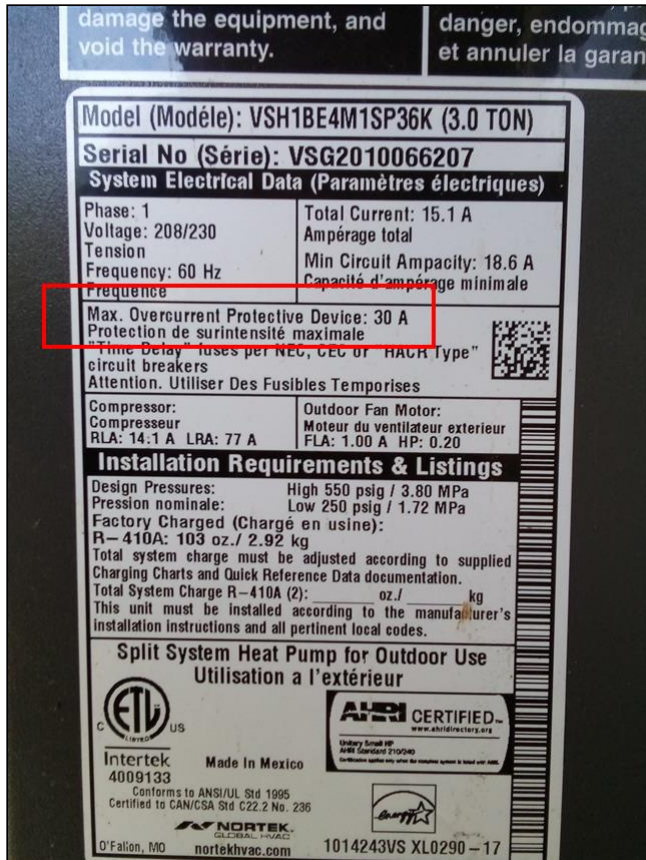
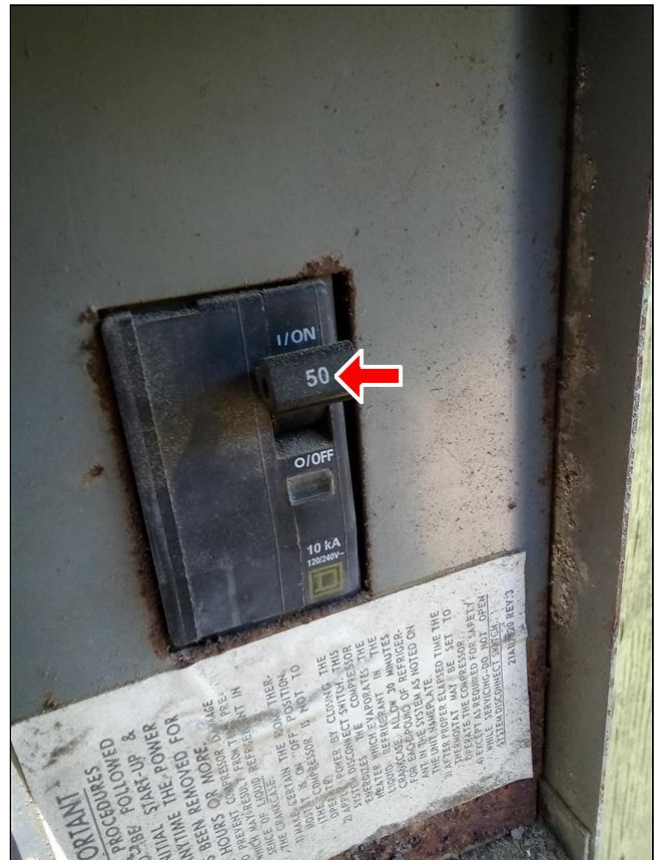
- 27 Heat pump unit appears to be overfused - typically missed when units are replaced. Maximum per data plate is 30 amps and there is a 50 amp breaker installed at the disconnect. Have a qualified electrical contractor evaluate and correct as needed to achieve normal, safe function.

7.2 Heat pump unit appears to be overfused - typically missed when units are replaced. Maximum per data plate is 30 amps and there is a 50 amp breaker installed at the disconnect. Have a qualified electrical contractor evaluate and correct as needed to achieve normal, safe function.
