Inspection Report

Property Address:
1212 Whispering Waters Way
Virginia Beach VA 23454

Date: 5/17/2021	Time: 12:00 PM	Report ID: 20210517-Great-Neck
Property: 1212 Whispering Waters Way Virginia Beach VA 23454	Customer: Blue Box Auctions	Real Estate Professional: Alexandrea Perecko RE/MAX Alliance

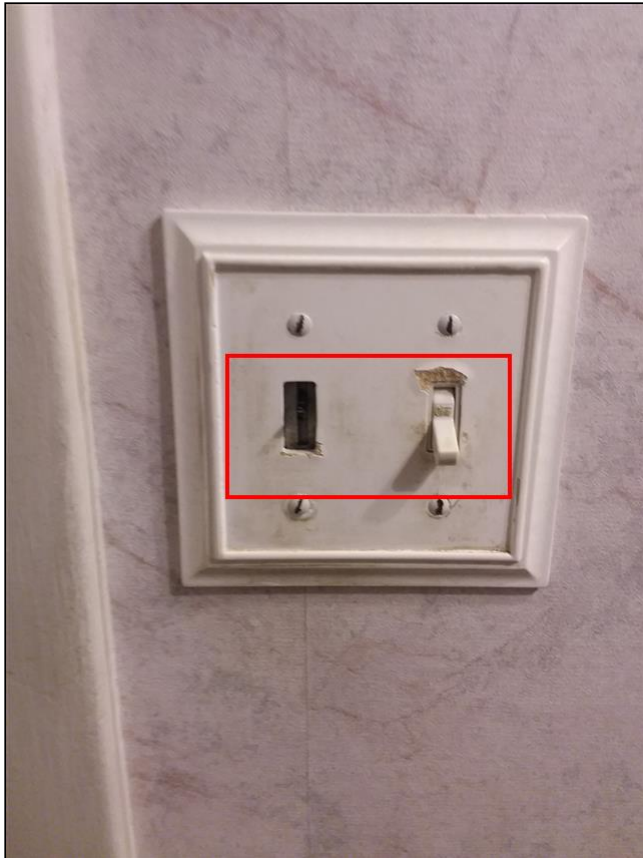
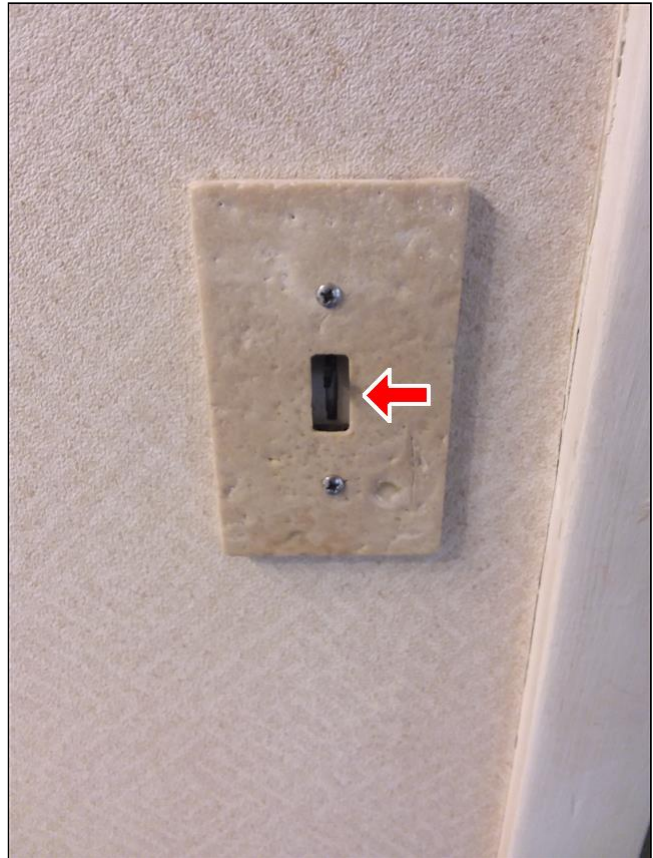
- 28 (1) Install switch plates / covers where missing or damaged.

Item 28 - Item 1(Picture) Hall bath

Item 28 - Item 2(Picture) Master bath

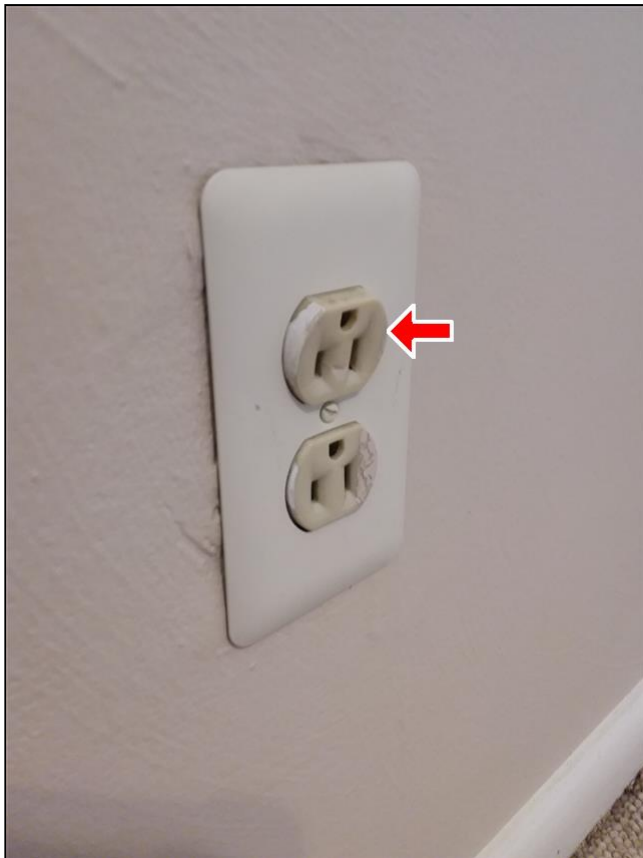
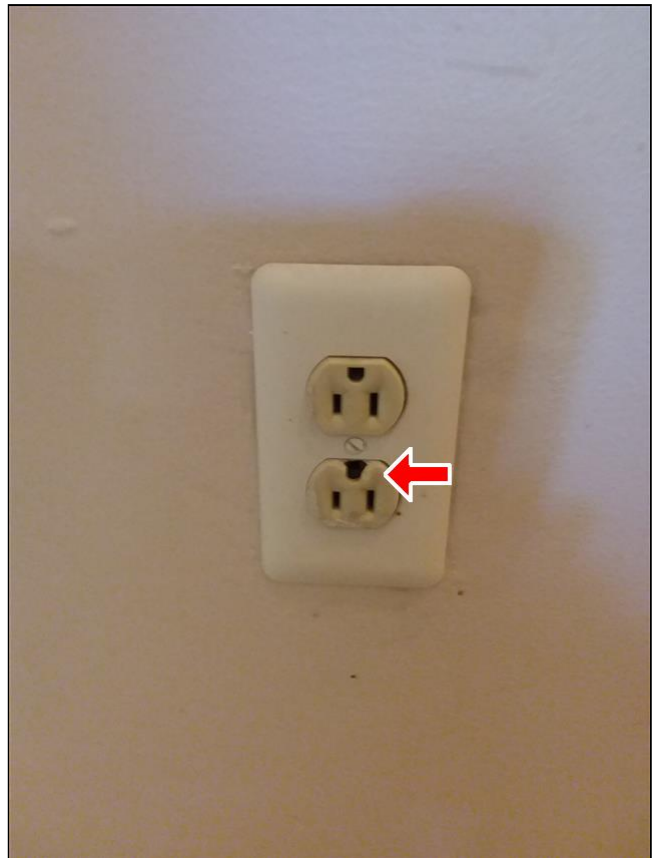
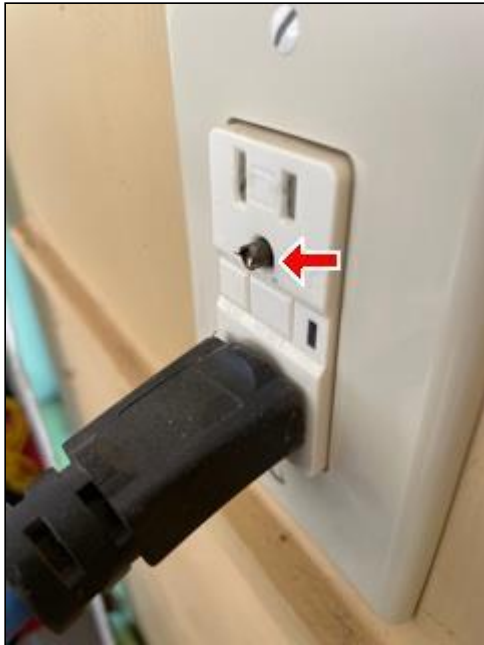
29 (2) Have a qualified contractor replace damaged outlets noted, but not limited to rear left bedroom, hall, and garage.

7.3 (2) Have a qualified contractor replace damaged outlets noted, but not limited to rear left bedroom, hall, and garage.

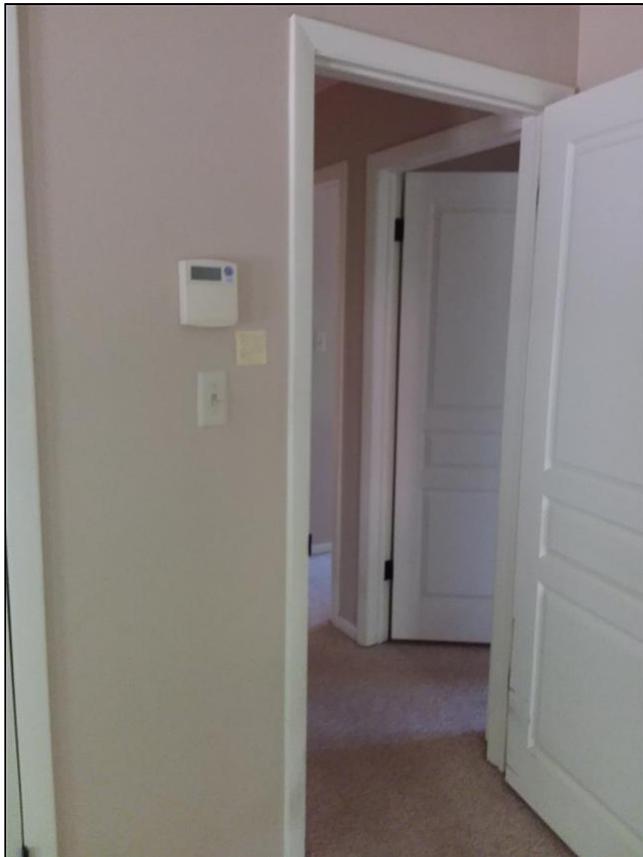
Item 30 - Item 1(Picture)

- 30 (3) There is not a switch controlled outlet or light fixture upon entering master bedroom. Have a qualified contractor evaluate and repair as needed.

7.3 (3) There is not a switch controlled outlet or light fixture upon entering master bedroom. Have a qualified contractor evaluate and repair as needed.

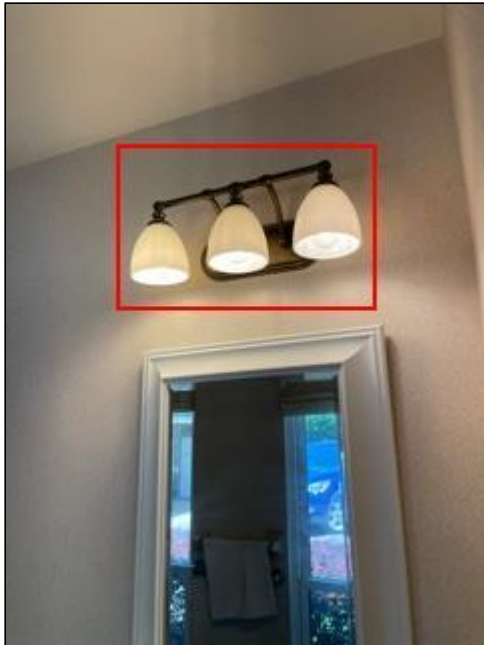
Item 31 - Item 1(Picture)

- 31 (4) The master bath lights flicker when in use. Have a qualified contractor evaluate and repair as needed.

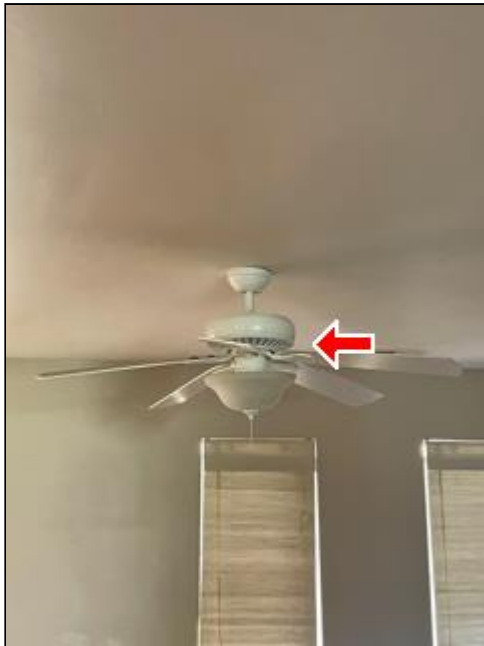
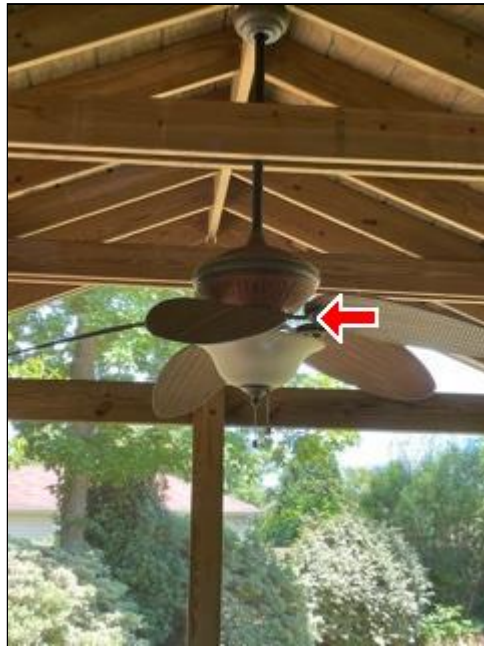
- 32** (5) Living room and exterior ceiling fans not functioning at time of inspection. Have a qualified contractor evaluate and repair / replace as needed.

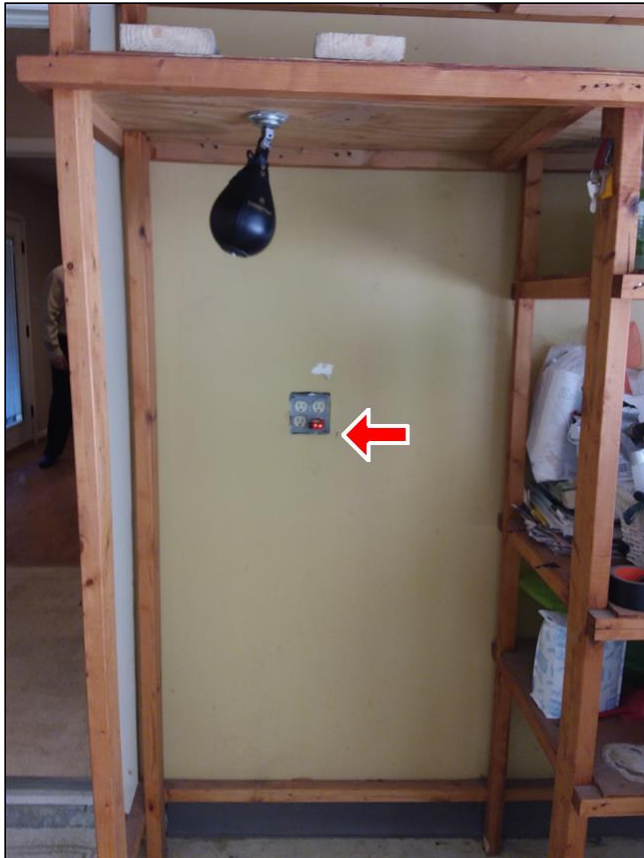
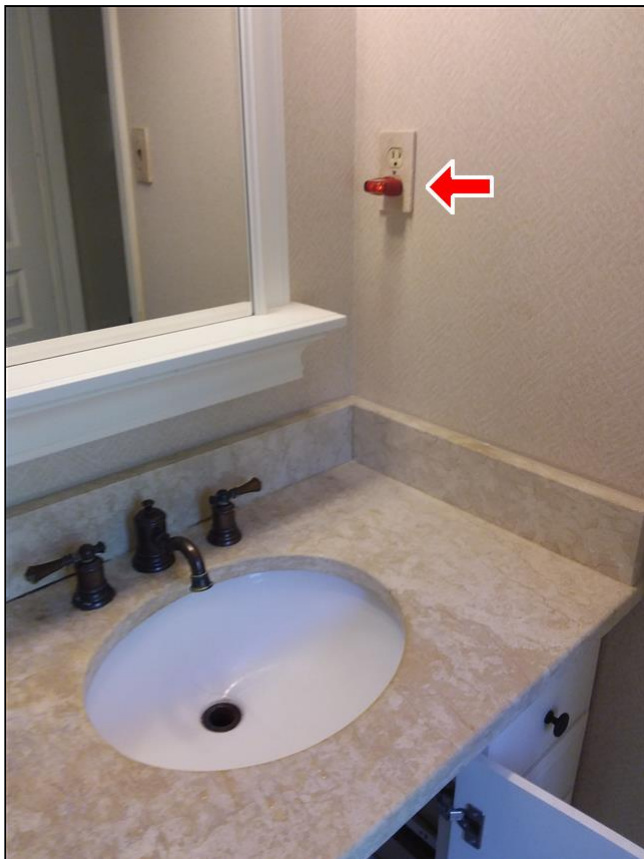
- 33** Install GFCI (shock) protection where missing at kitchen, bathroom, garage and exterior outlets.

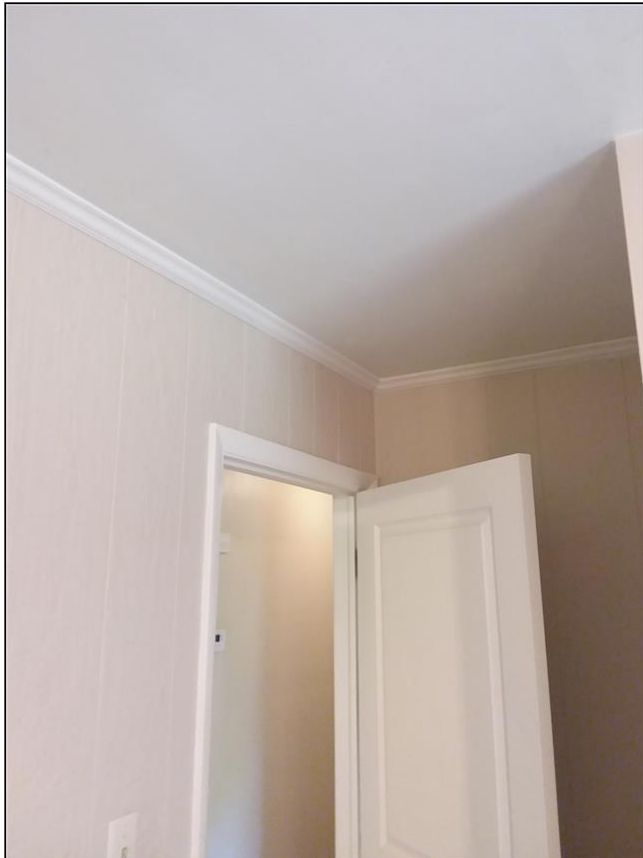
Item 36 - Item 1(Picture)

- 36 (1) Install smoke detectors where missing in sleeping areas.

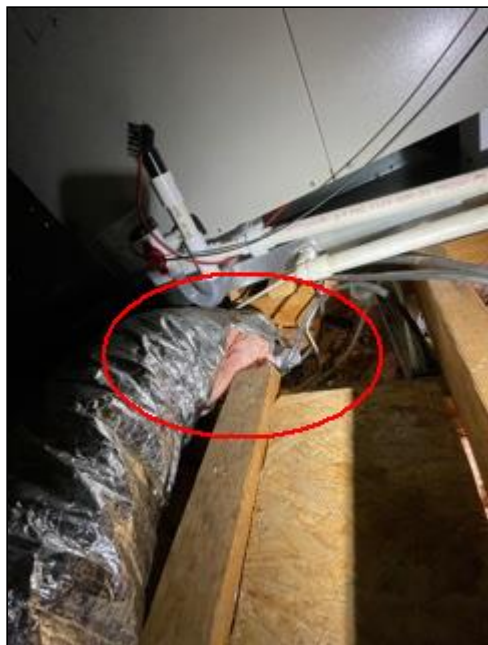
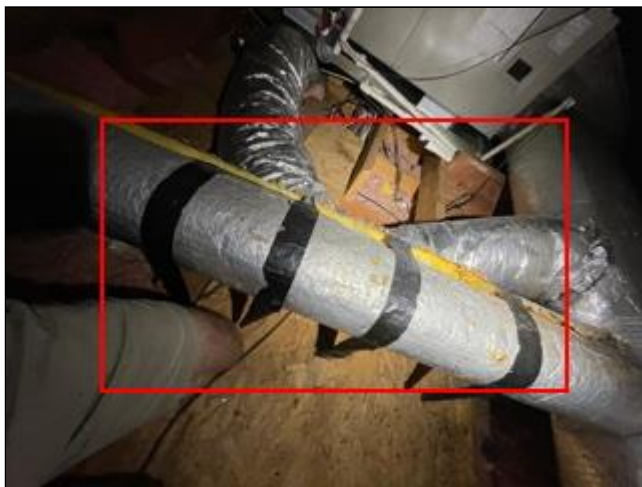
- 37 Have a qualified HVAC contractor evaluate ducts in the attic. Seal gaps and insulate where missing.

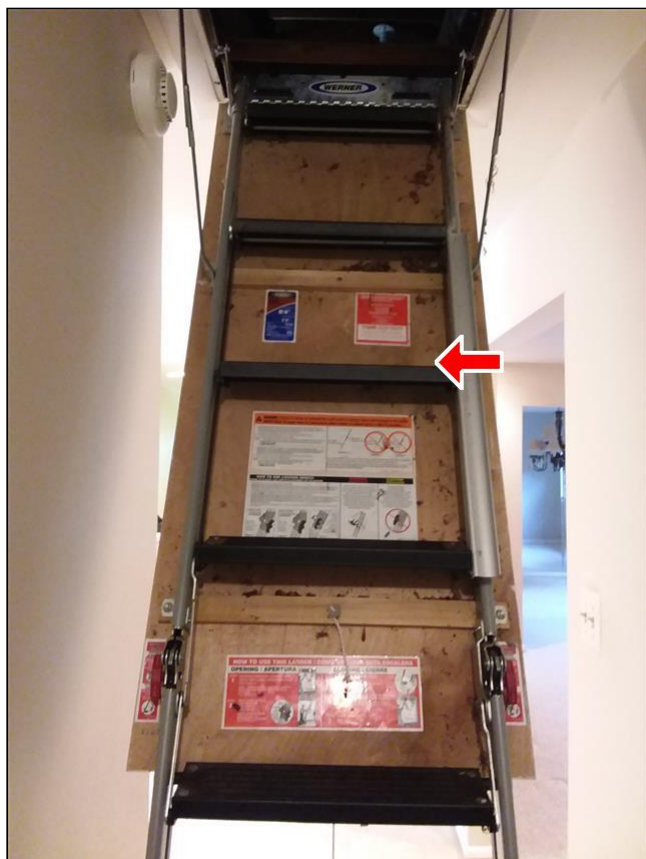
Item 38 - Item 1(Picture)

- 38 Install insulation where missing at pull down stairs.

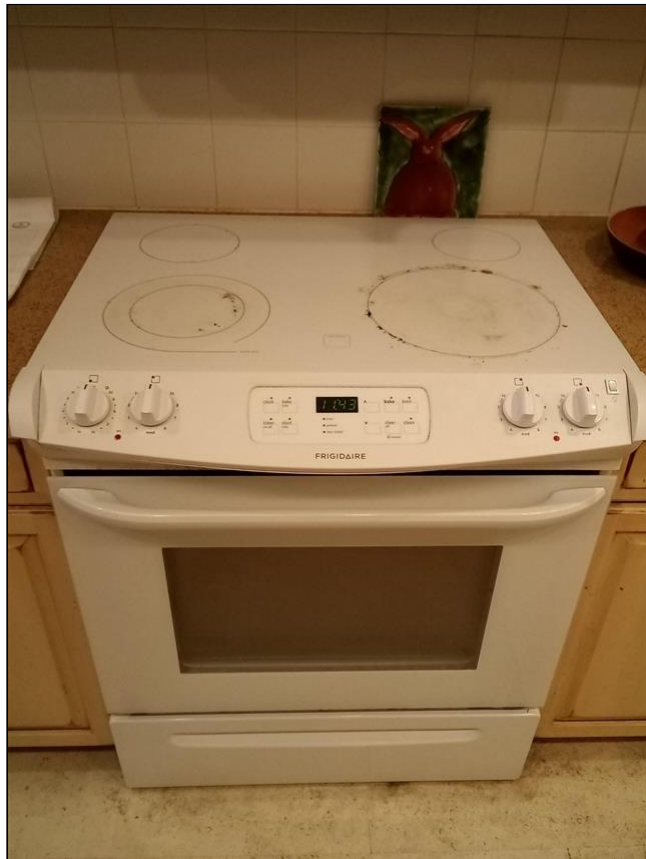
Item 39 - Item 1(Picture)

- 39 Supplied anti tip bracket has not been installed. This is a potential safety concern. Suggest repair by a qualified professional.
